Miscellaneous Paper SL-96-1  
February 1996

## Forced Entry Testing of Five-Minute Walls

Prepared for U.S. Department of State,  
Office of Foreign Building Operations

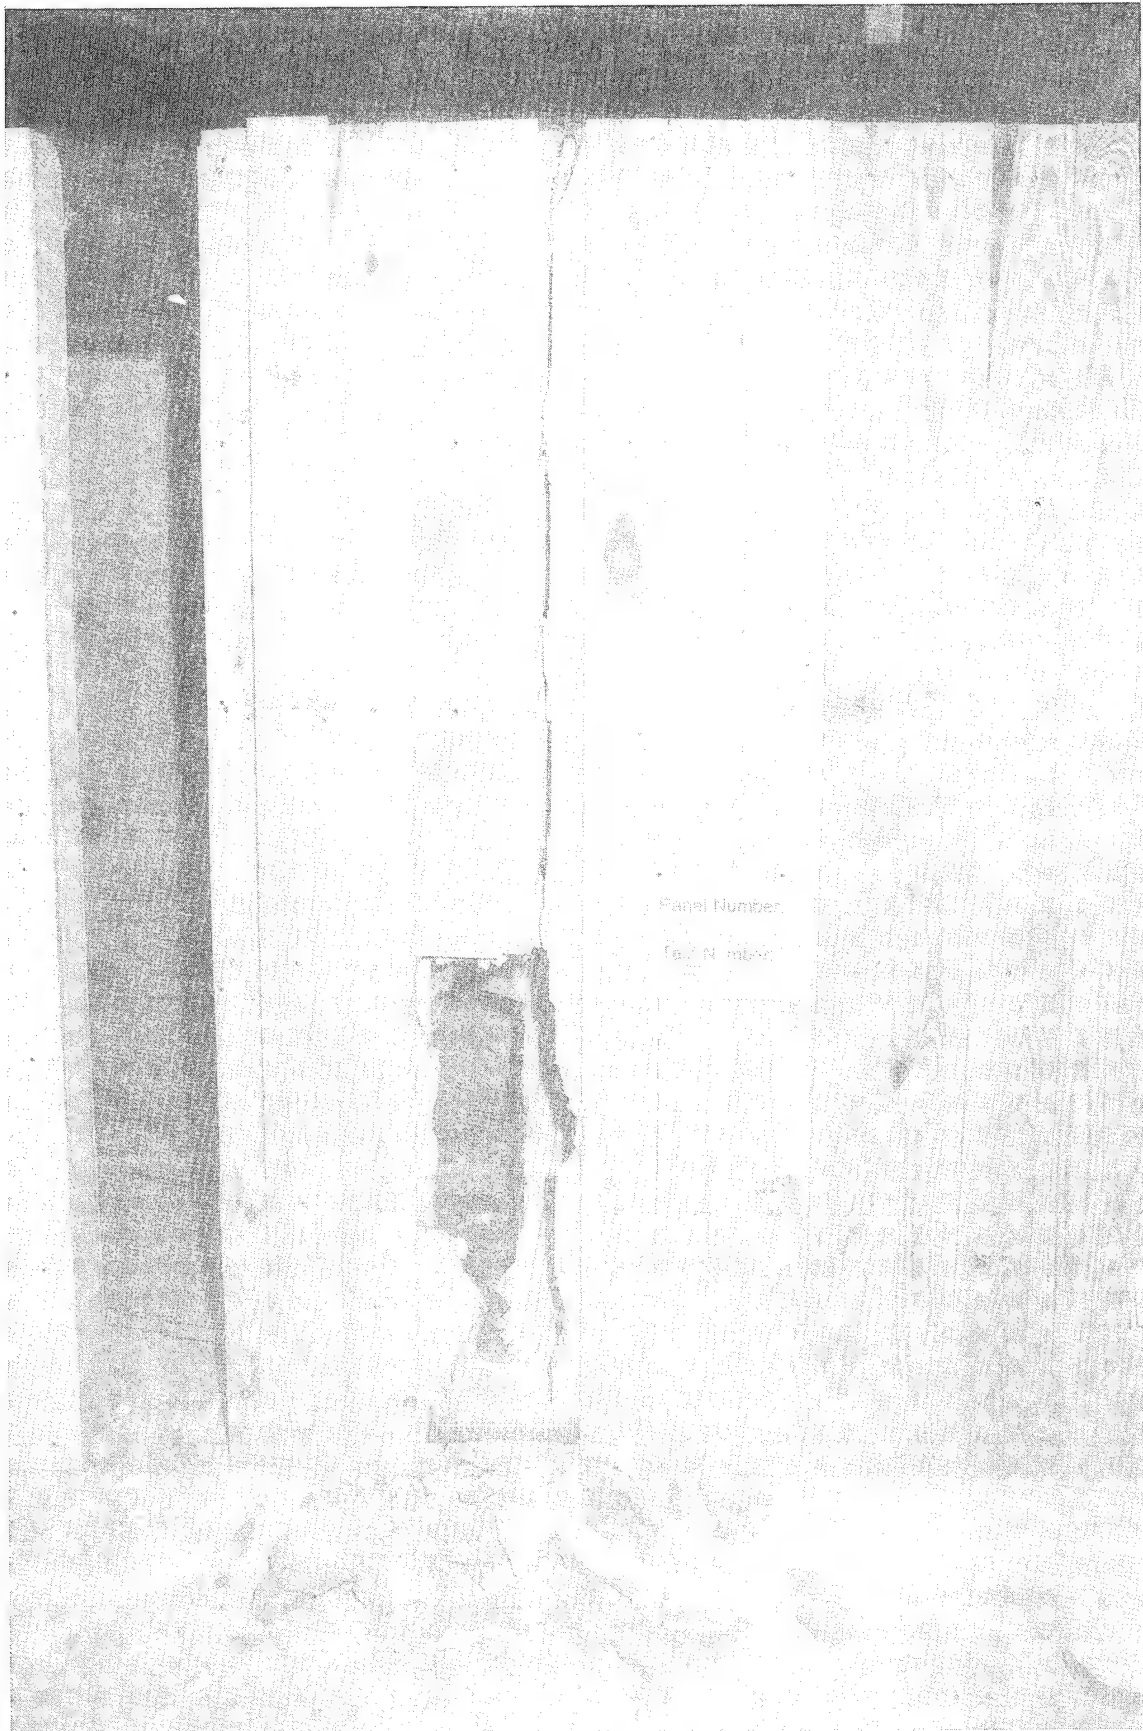
Figure 57. Assault side of panel XPK-05N-DOS-05 after test 5-1

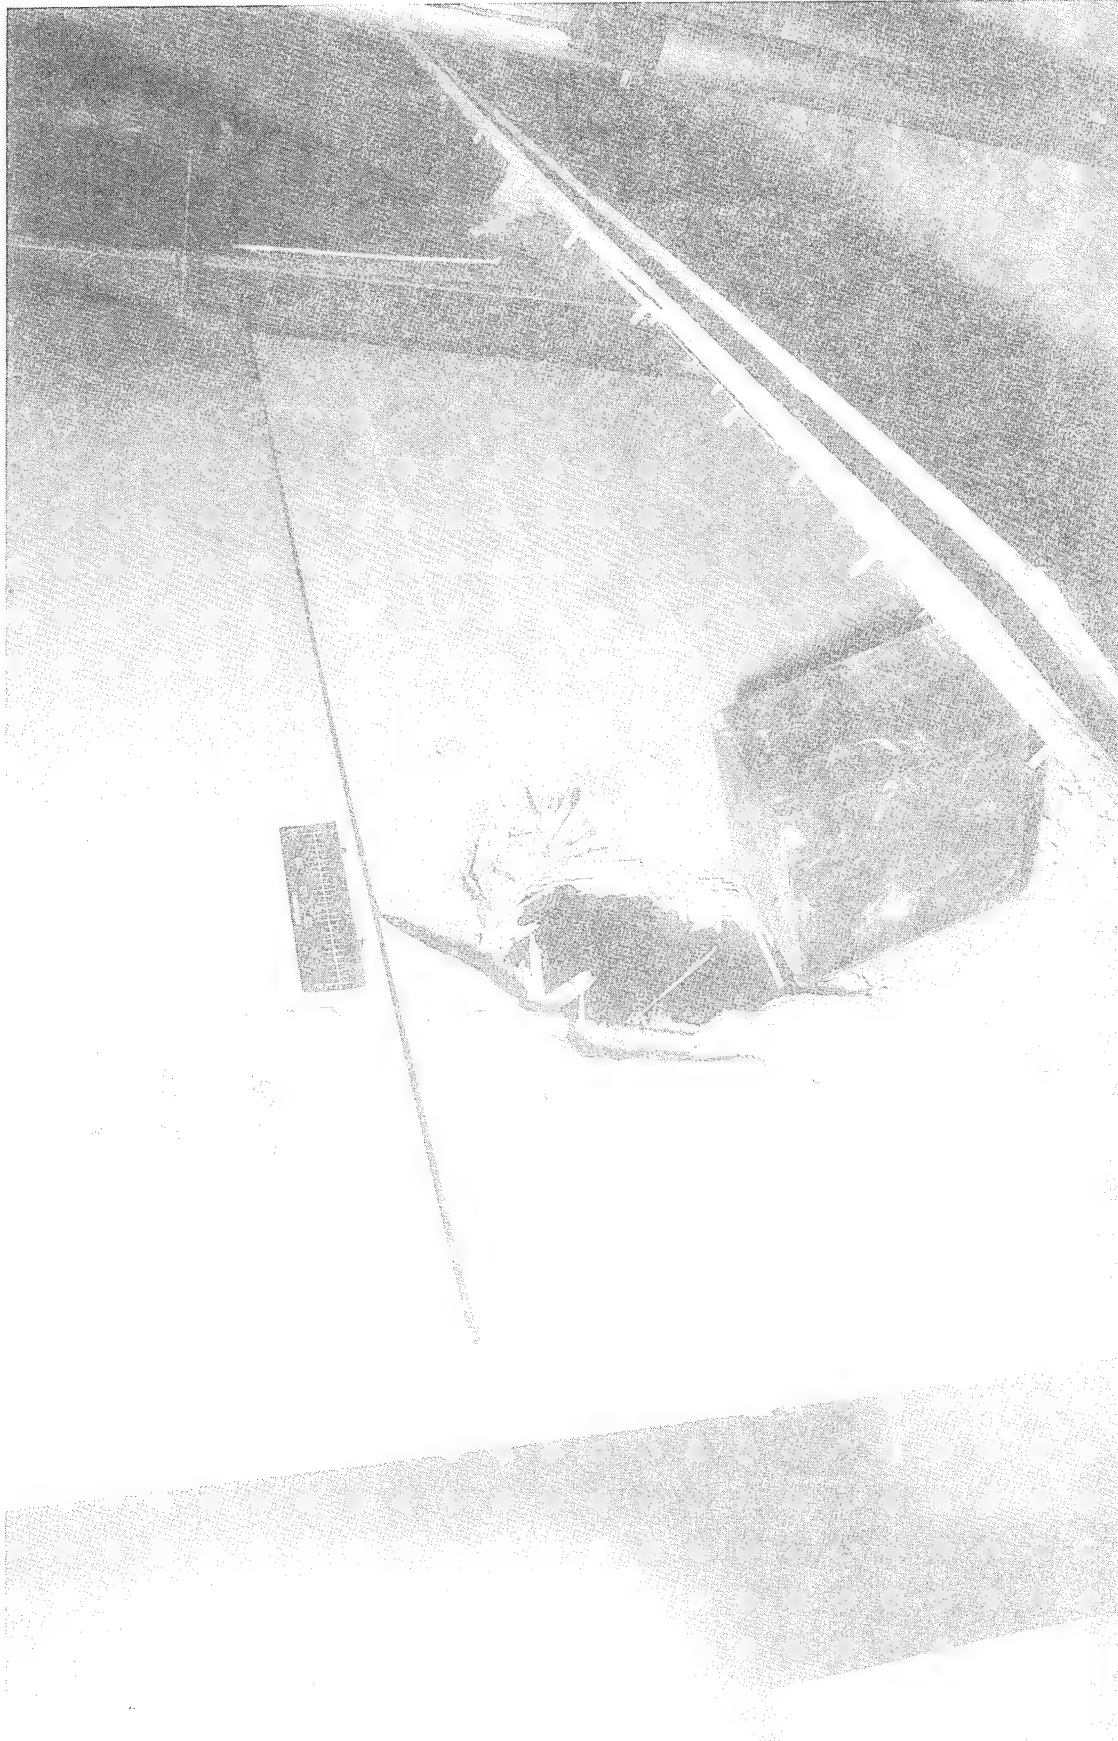
Figure 60. Protect side of panel XPK-05N-DOS-06 after test 6-1
